**Flood Control Project Maintenance
Levee Inspections**
2009 Channel Summary Report
Overall Unit and Item Ratings

Placer County

Truckee River

Flood Control Project Maintenance**Unit Cover Sheet****2009 Channel Inspection Results****Placer County**

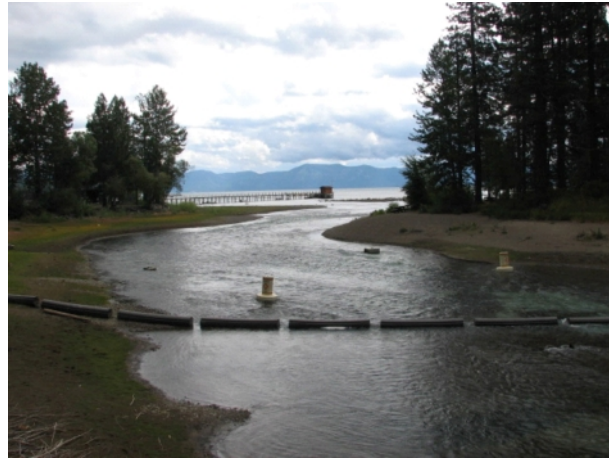
Levee Mile Report Line	1
Start Levee Mile	0.00
End Levee Mile	0.00
Location	
Category	Channels
Item	Vegetation & Obstructions
view is from the outlet structure looking towards Lake Tahoe	
johngw_20090810_54.jpg

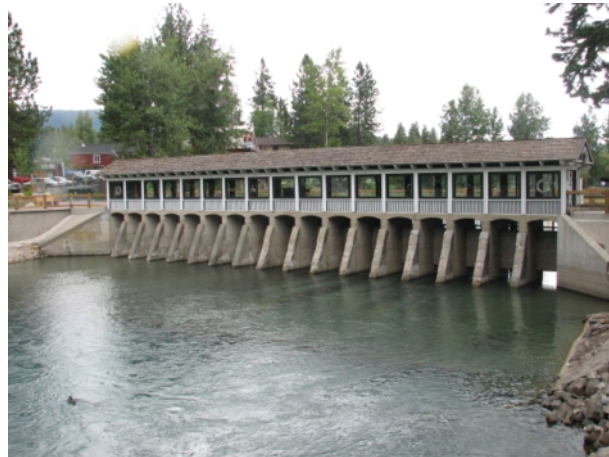
Levee Mile Report Line	11
Start Levee Mile	0.00
End Levee Mile	0.00
Location	
Category	Channels
Item	Vegetation & Obstructions
looking at downstream side of outlet structure GPS HWY 89 39.16692 -120.14431	
johngw_20090810_55.jpg

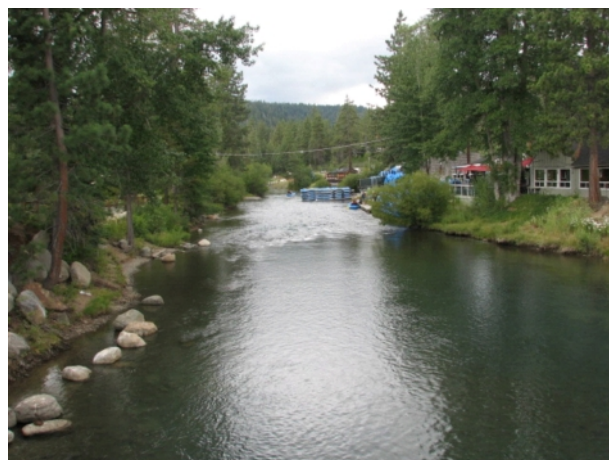
Levee Mile Report Line	16
Start Levee Mile	0.00
End Levee Mile	0.00
Location	
Category	Channels
Item	Vegetation & Obstructions
downstream from HWY 89 GPS 39.16692 - 120.14431	
johngw_20090810_56.jpg

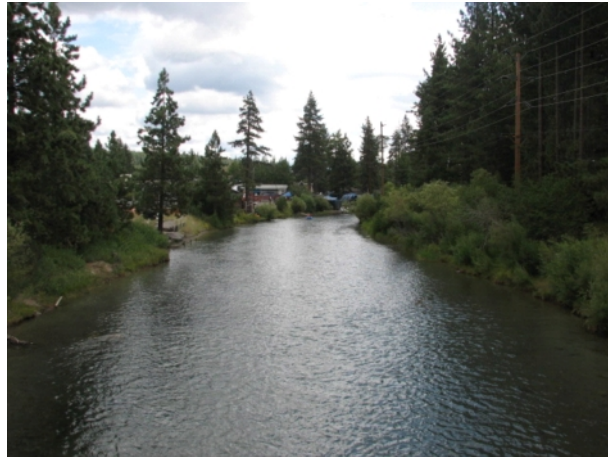
Levee Mile Report Line	21
Start Levee Mile	0.00
End Levee Mile	0.00
Location	
Category	Channels
Item	Vegetation & Obstructions
view from bike bridge GPS 39.16517 -120.14759	
johnngw_20090810_57.jpg

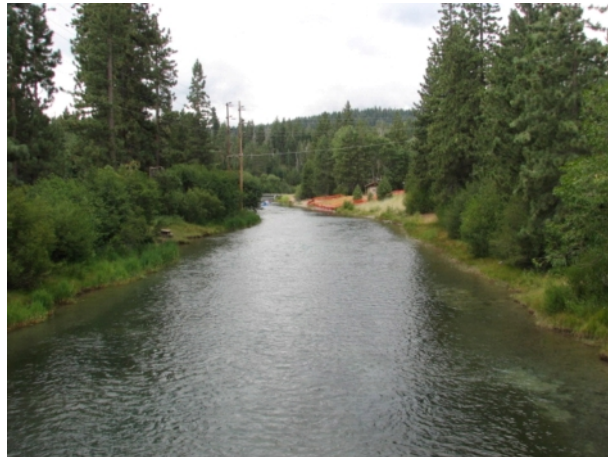
Levee Mile Report Line	26
Start Levee Mile	0.00
End Levee Mile	0.00
Location	
Category	Channels
Item	Vegetation & Obstructions
downstream from bike bridge GPS 39.16517 - 120.14759	
johnngw_20090810_58.jpg

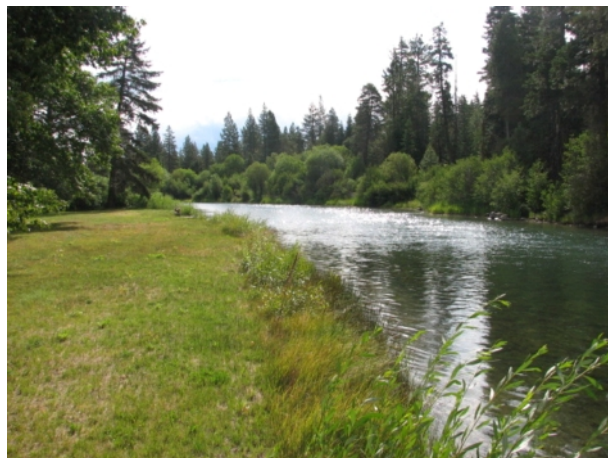
Levee Mile Report Line	31
Start Levee Mile	0.00
End Levee Mile	0.00
Location	
Category	Channels
Item	Vegetation & Obstructions
upstream look at eastern end of lumberyard GPS 39.16251 -120.15152	
johnngw_20090810_59.jpg

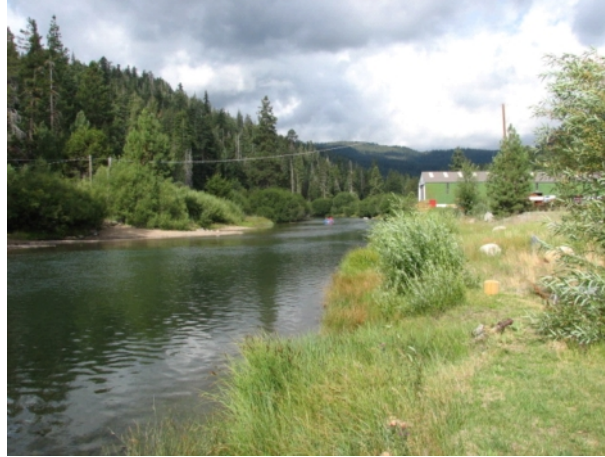
Levee Mile Report Line	36
Start Levee Mile	0.00
End Levee Mile	0.00
Location	
Category	Channels
Item	Vegetation & Obstructions
downstream look at lumberyard GPS 39.16251 - 120.15152	
johngw_20090810_60.jpg
